## Continuing Education

Advertising supplement provided Jeld-Wen Windows &amp; Doors

Use the following learning objectives to focus your study while reading this month's ARCHITECTURAL RECORD / AIA Continuing Education article.

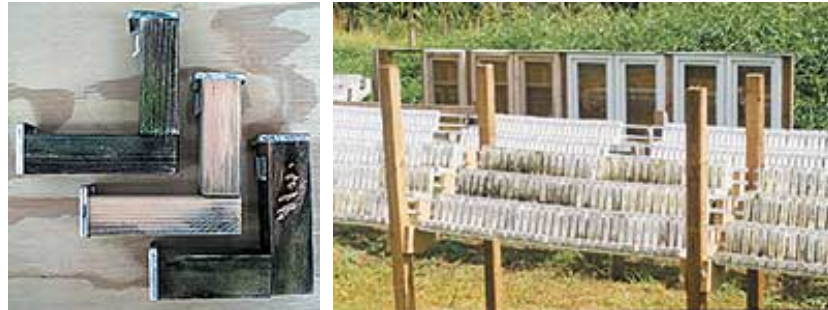
Left: Three unpainted L-joints in our greenhouse after 29 months exposure. The middle one is treated with the new process (machined from treated stock), with an untreated to the left (one of 3 of 10 that had not already failed), and on the right (fungus growing out) is a IPBC dip treated L-joint. Right: L-joints and window units in Hilo.

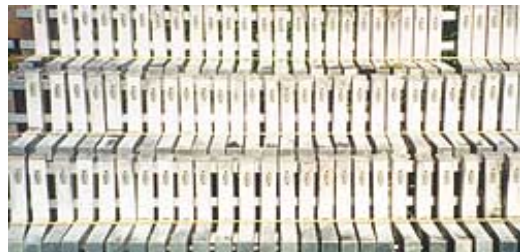
Top: L-joints during exposure in Hilo with differences in mold on paint. Bottom: Greenhouse setup of L-joints for artificial spraying of water.
